Results of the NIST National Ball Plate Round Robin

**G. W. Caskey, S. D. Phillips, and
B. R. Borchardt**

National Institute of Standards and
Technology,
Gaithersburg, MD 20899-0001

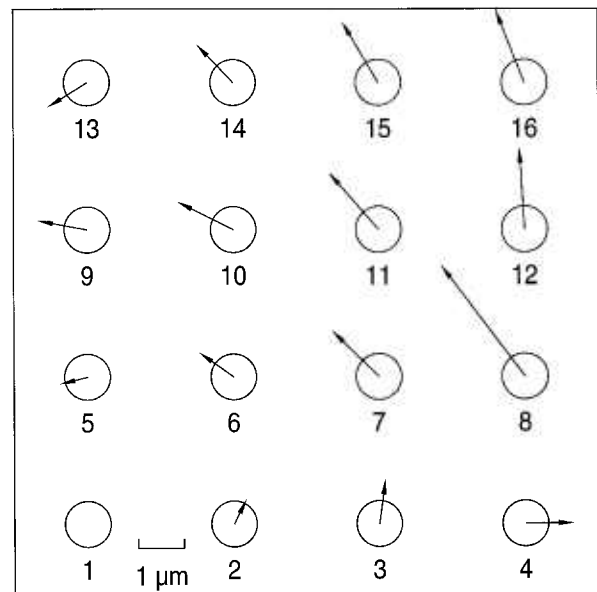
Fig. 2. Graphical representation of shift in ball plate sphere centers. The maximum change in center coordinates, in excess of 3 μm , occurred on ball number 8.

During the remeasurement of the plate by NIST at the end of the round robin, it was discovered that there was an apparent systematic shift in sphere center. The magnitude and direction of the change in these coordinates, shown graphically in Fig. 2, is consistent with a distortion occurring predominately on the right side of the plate. The average magnitude of the ball center coordinate change in this area was approximately 2 μm , with a maximum change of more than 3 μm occurring at ball number 8.

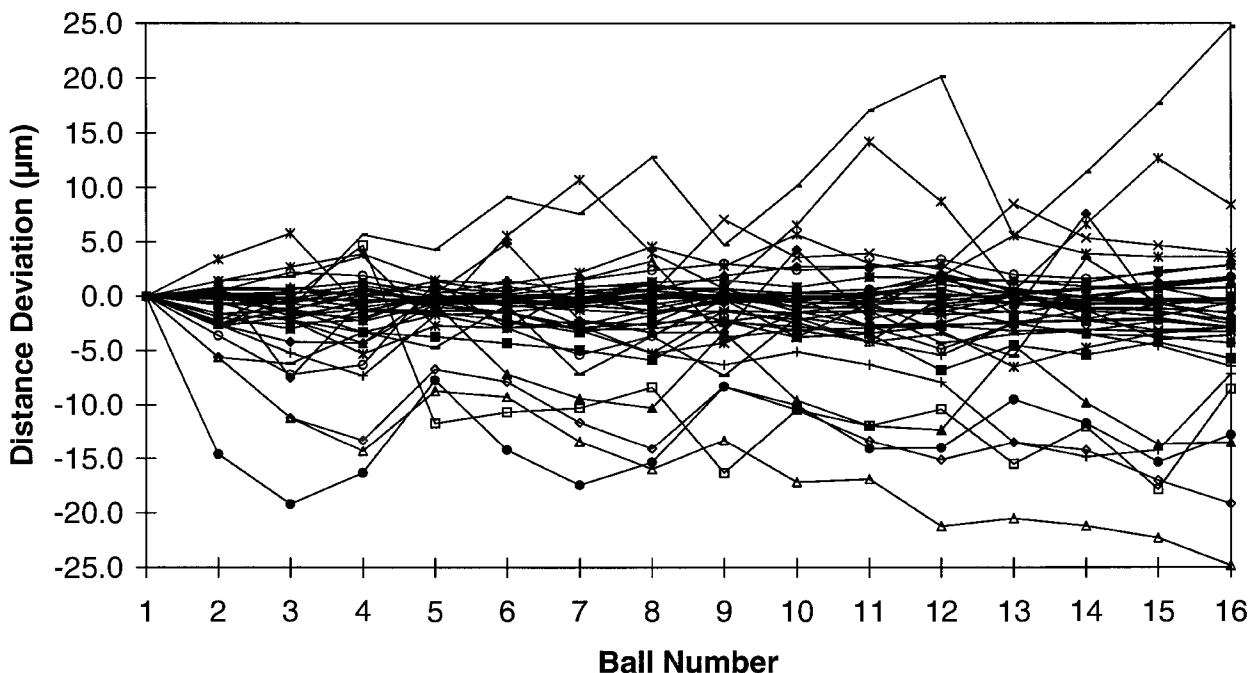
Fig. 3. The deviations in the sphere distances, between ball number 1 and the remaining 15 balls, with respect to the NIST calibrated values.

The results of the ball plate round robin are shown in Figs. 3 through 7. Figure 3 shows the deviations in distance from ball number 1 (the ball plate measurement system origin) for all of the participants. The authors realize that choosing to analyze only the set of distances from ball number 1 can have the effect of biasing the individual participants' deviation data since the measurement of ball number 1 is itself not without error. However, the prescribed procedure for establishing a common ball plate coordinate system was very much analogous to establishing a part coordinate system and/or part datums which are integral to the discrete part measurement process with a CMM. Therefore, analyzing the data in this way was more closely aligned with the objectives of the round robin.

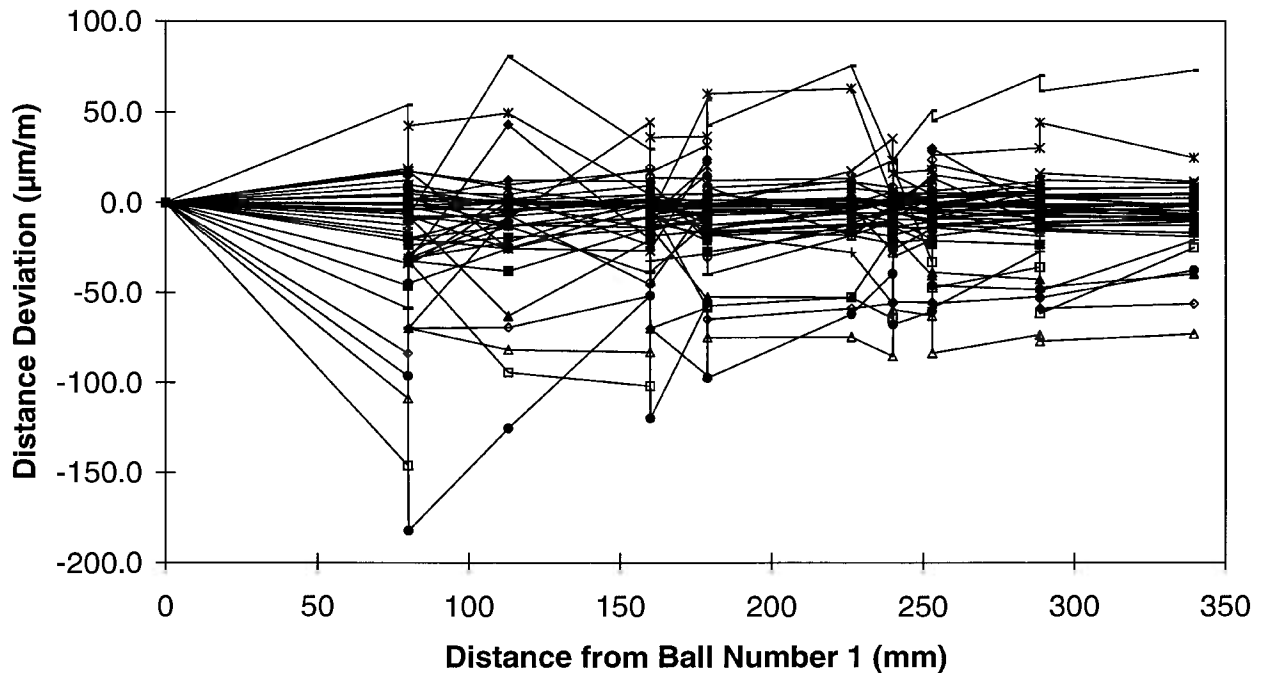
Fig. 4. The distance deviations from Fig. 1 expressed as a fraction of the distance from ball number 1.

A similar plot, Fig. 4, shows these same distance deviations expressed as a fraction of each sphere's distance from ball number 1. Analyzing the data in this manner provides an indication of how well the individual machines could measure two-dimensional features of various lengths. As evident from the plot, the majority of the machines are within $\pm 50 \mu\text{m/m}$ of feature length. Although those data are correct as presented, they are somewhat misleading over short distances where the non-repeatability of the CMM tends to be the predominate error source. In this regime the distance

deviations expressed as a fraction of the feature length can be inflated since the non-repeatability effects remain constant even as the measurement length becomes small.

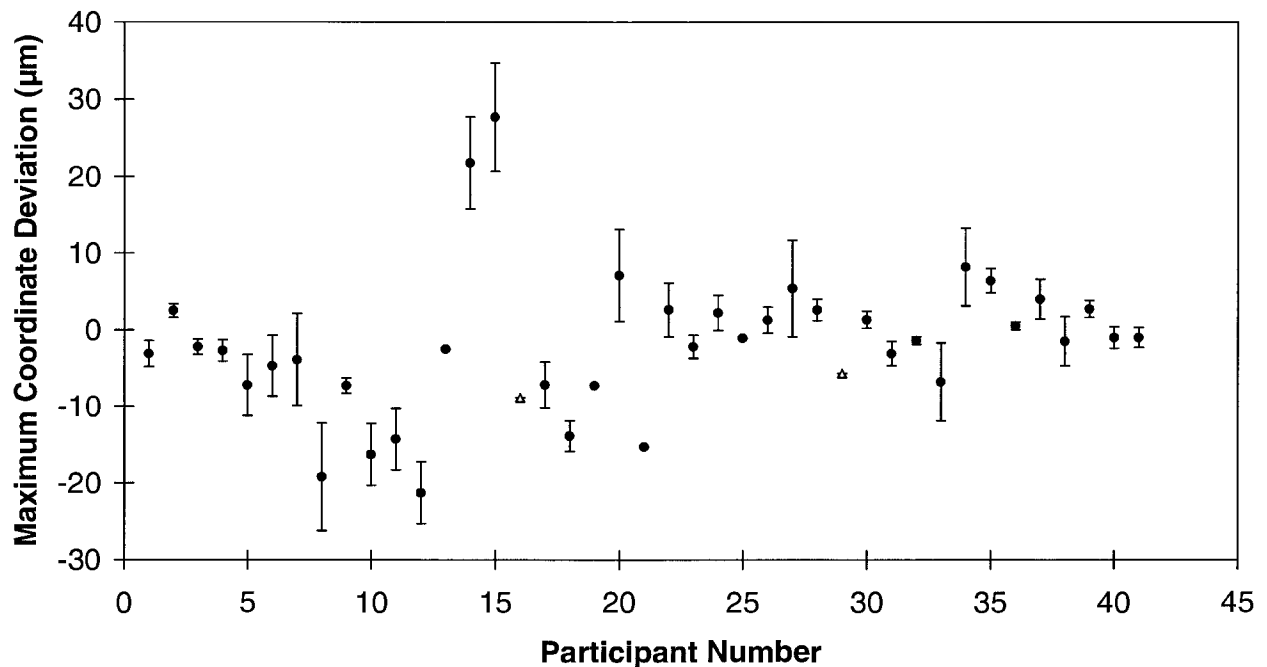
Fig. 5. Maximum coordinate deviations (from the calibrated values) along with participants measurement error estimates. The deviations are represented by the solid circles and the error estimates by the error bars. Several participants did not provide an error estimate and their deviations are denoted by the triangles.

Data reporting for this round robin, by the participants, was supposed to include an estimate of the "measurement error" which was defined as 3 standard deviations of the observed measurements arithmetically added to any estimated systematic errors.¹ Providing an estimate of their measurement error proved to be difficult for some of the participants, with responses varying from the estimates as requested to no estimates at all. Figure 5 shows the measurement error estimates (\pm) plotted around the maximum sphere center coordinate deviation reported by each participant. These deviations were chosen without regard to ball number or coordinate (X or Y).

It can be seen from this plot that the maximum deviations for a majority of the participants are within ± 10 μm . However, as was previously discussed there are additional error sources not revealed by the ball plate measurement results which can further degrade actual CMM performance. Therefore, it is somewhat disturbing that over 75 % of the participants failed to correctly estimate their measurement error on at least one of the ball plate spheres. (Figure 5 does not necessarily represent the worst case error estimation since the maximum coordinate deviation and the worst case error estimates need not occur on the same ball.) This further supports the call for more realistic CMM uncertainty estimation technique development by the CMM community as a whole.

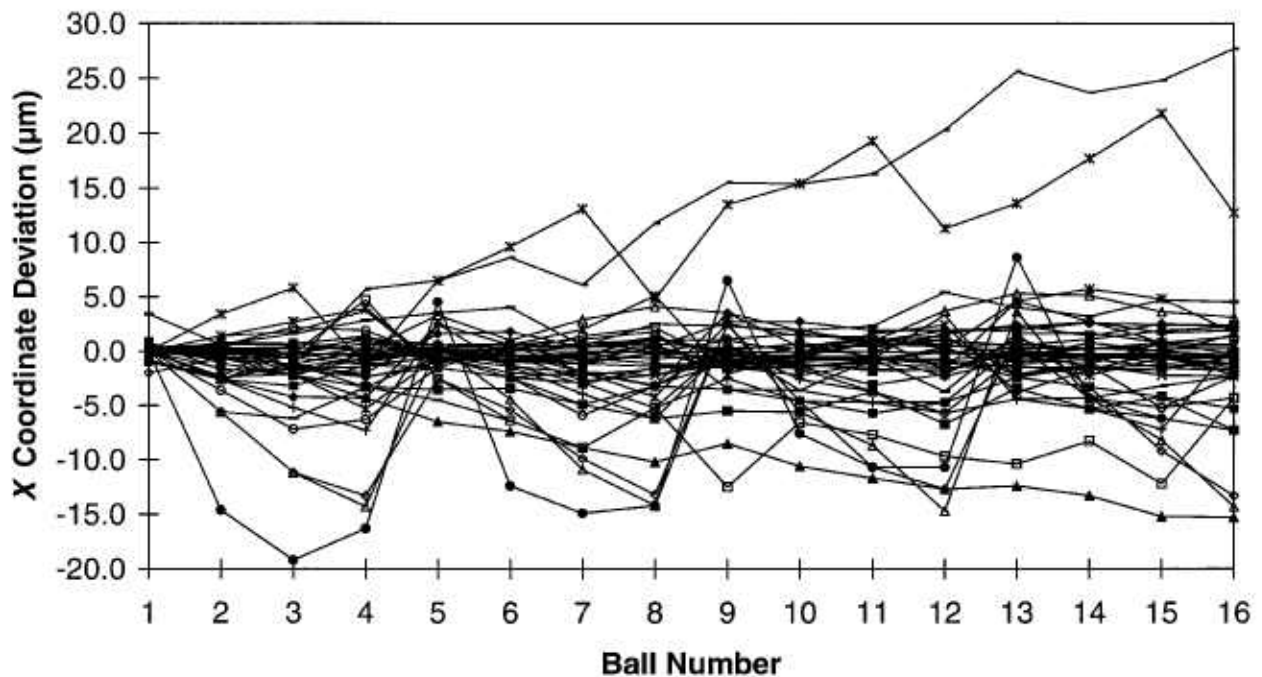
Fig. 6. X coordinate deviations, from the calibrated values, for all round robin participants.

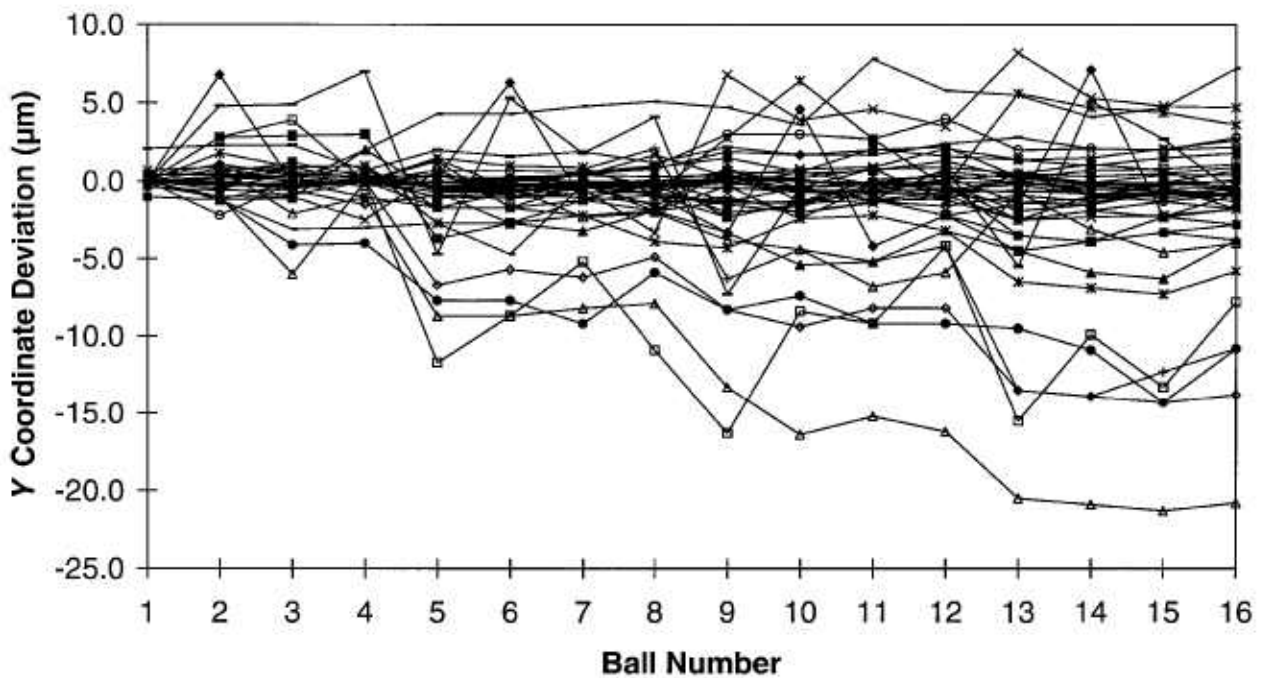
Fig. 7. Y coordinate deviations, from the calibrated values, for all round robin participants.

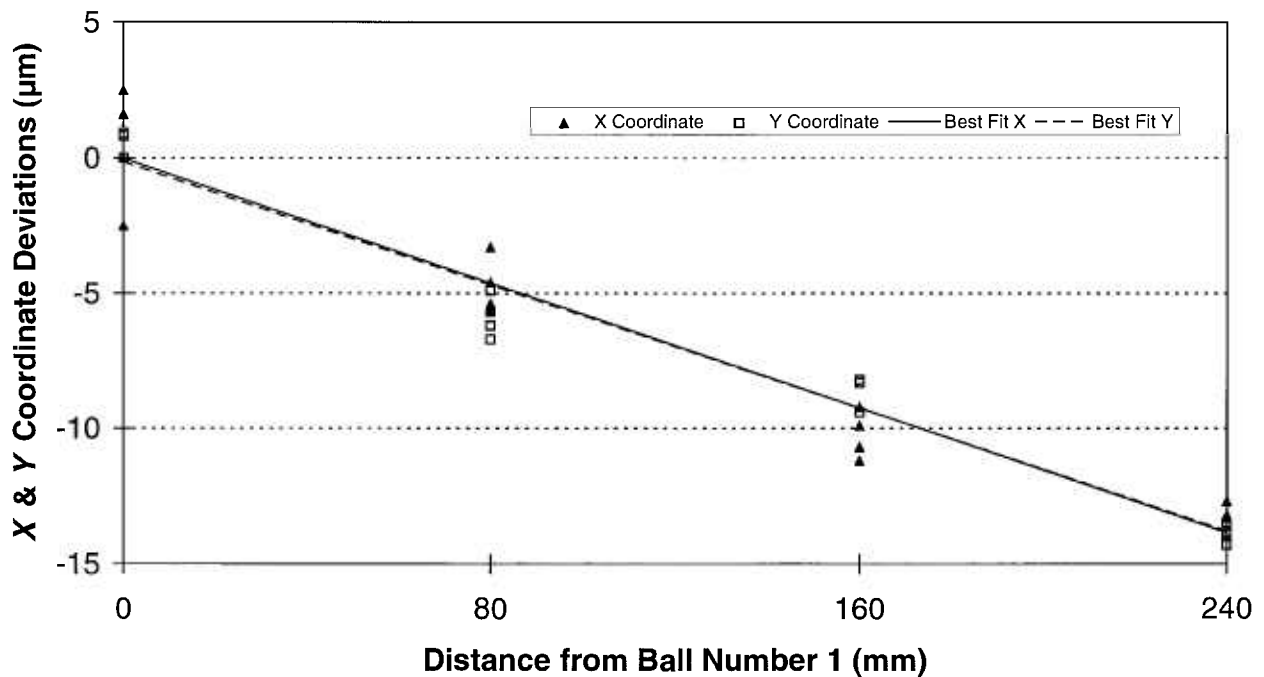
Fig. 8. A thermal error indicated by one participant's data, likely caused by improper thermal compensation of the CMM scales. The error here is approximately 54 $\mu\text{m}/\text{m}$ indicating a temperature difference of 6 $^{\circ}\text{C}$ to 7 $^{\circ}\text{C}$ ($\sim 11^{\circ}\text{F}$ to 13 $^{\circ}\text{F}$).

Without imposing a rigorous measurement strategy on the participants, it would be difficult to deconvolve all of the individual errors for a series of independent ball plate measurements such as this round robin data. This is due to the highly interdependent nature of the these errors. However, we may examine the individual X and Y coordinate deviations looking for patterns in the data. As can be seen from Figs. 6 and 7, much of this data display a systematic structure, and in some cases, it is possible to identify one or more of the dominant errors. For instance, by comparing the X and Y coordinate deviations for a single set of measurements, it is possible to identify relative scale errors and/or thermal errors. If the deviations of the individual X and Y ball coordinates are approximately equal, as in Fig. 8, then a thermal error is suspect. This type of error could result from a failure to properly correct for ball plate expansion, CMM scale expansion, or both, when the measurements are made at a temperature other than the standard reference temperature (20 °C). The error shown in Fig. 8 is most likely the result of correcting the measurement data for ball plate thermal expansion while failing to correct for the CMM scale thermal expansion. This would account for the negative trend in the data, amounting to an error of approximately 54 $\mu\text{m}/\text{m}$ indicating CMM scale temperatures of 26 °C to 27 °C (79 °F to 81 °F)—which is representative of many manufacturing facility environments.

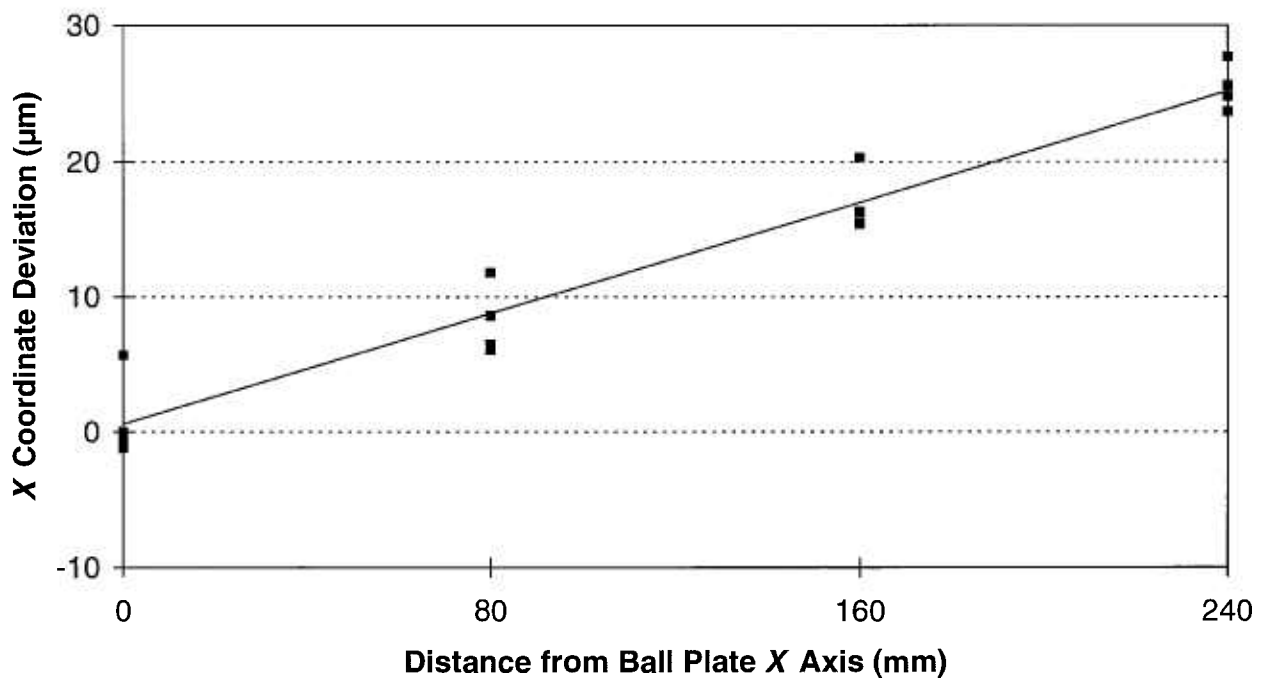
Fig. 9. One participant's data showing an out-of-squareness error. In this case the error is 100 μrad (approximately 20 arcseconds).

Another identifiable error is the out-of-squareness between the two measurement axes. Since the X axis of the ball plate was defined by the plate coordinate system, any squareness error would appear as an out-of-squareness of the Y axis with respect to the X axis. (The assignment of out-of-squareness to either of the axes is purely arbitrary as long as the magnitude, direction and effect on the measured coordinates is understood.) Therefore, by viewing the X deviation data in groups of nominally equal Y coordinates, any out-of-squareness between the X and Y axes will become apparent. Figure 9 shows evidence of a classical out-of-squareness error for one participant's CMM. In this case the out-of-squareness is calculated as 100 microradians (approximately 20 arc seconds) of error.
